FORENSIC EVIDENCE SUMMARY

Analysis of Physical Evidence and Video Forensics

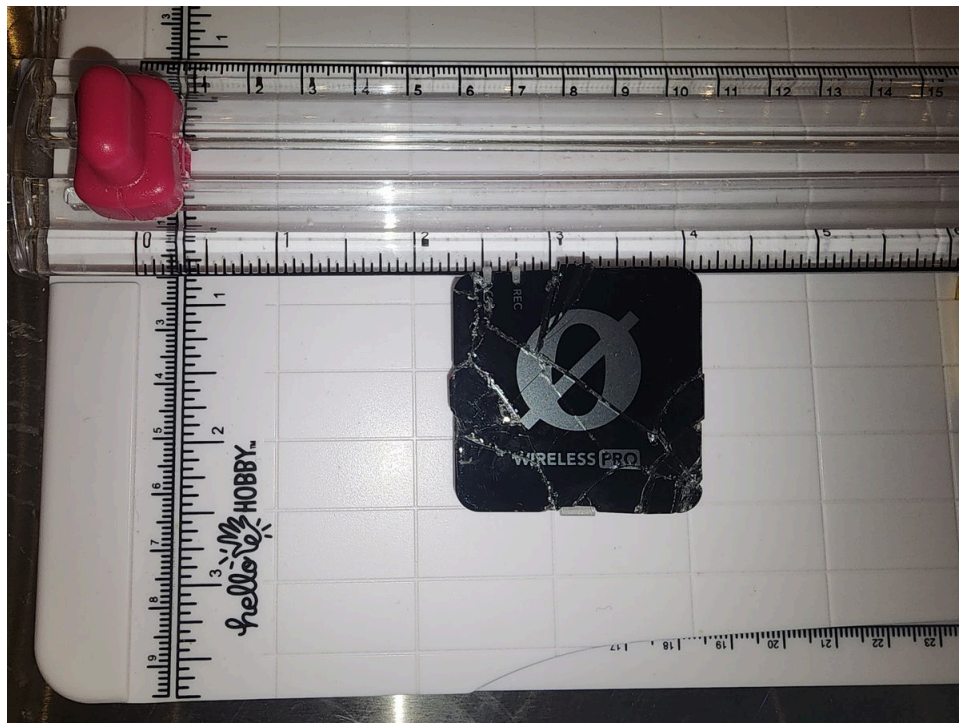
Exhibit A-3: RODE Wireless PRO transmitter exterior. Note the glass front face (shown cracked in this exemplar unit). The device measures approximately 44mm x 46mm.

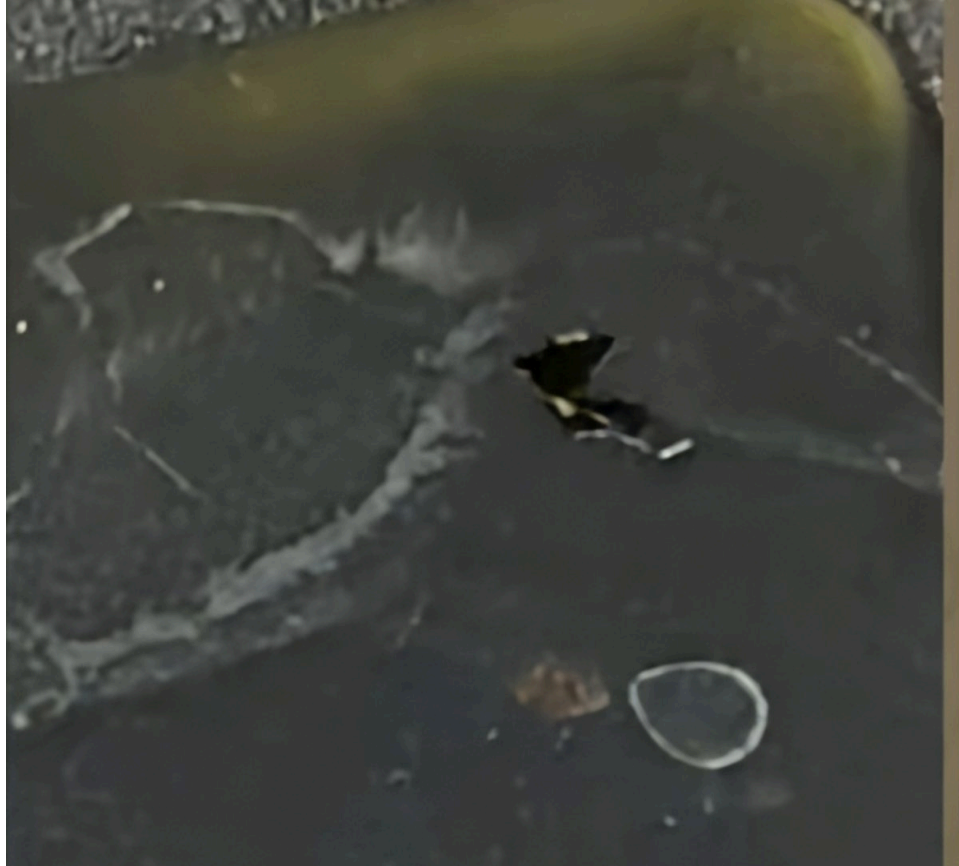
Exhibit C-1: Close-up of the damaged RODE Wireless PRO transmitter. Printed font and a beveled edge can be seen on the fragmentation. The beveled edge and printed font can be seen on the fragmentation.

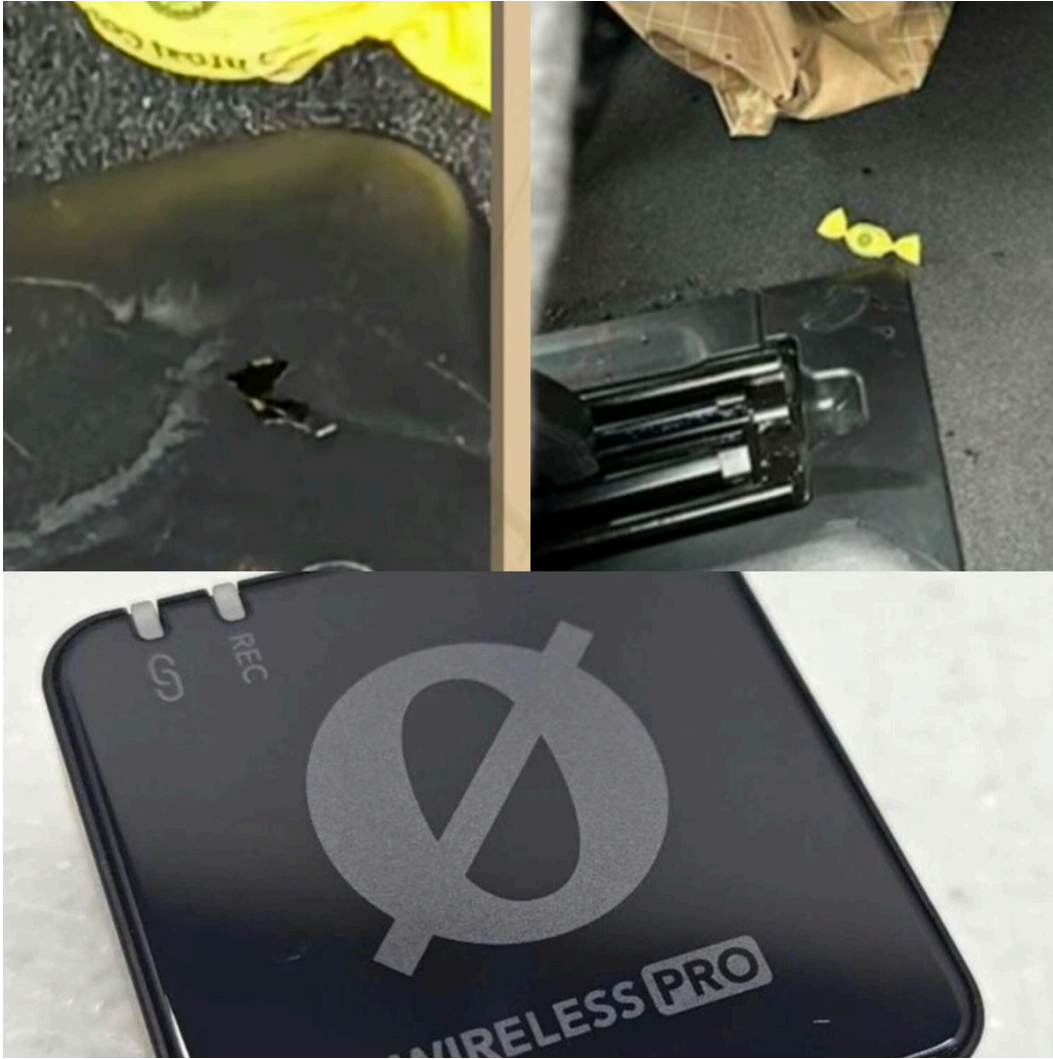
Exhibit C-2: Composite image. Top left: Close-up of the damage to the transmitter glass face. Top right: Transmitter debris on the floorboard of the SUV that transported the victim to the hospital. Bottom: Intact RODE Wireless PRO transmitter for comparison.

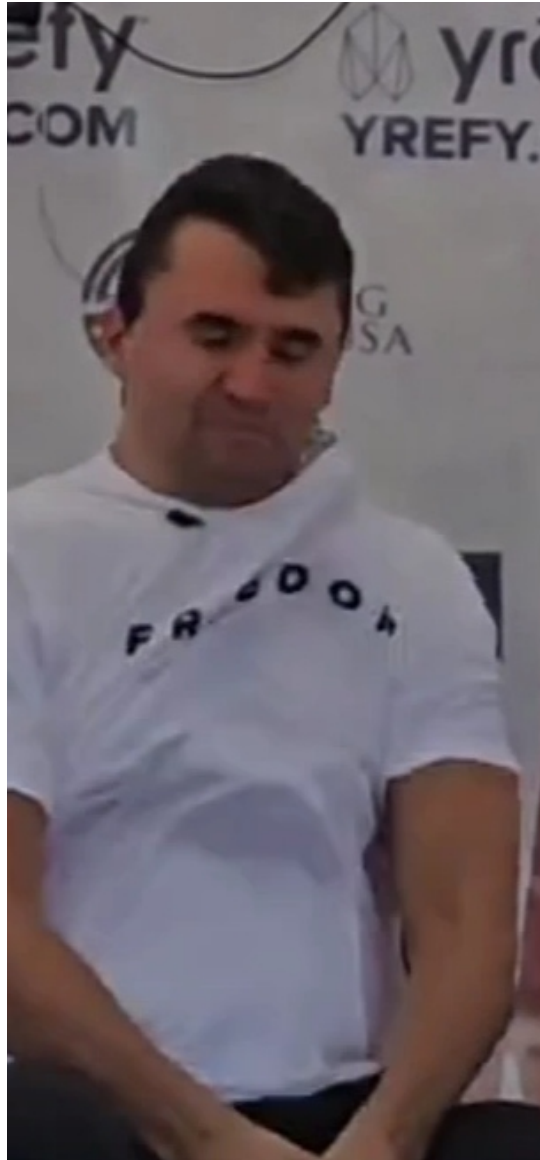
Exhibit D-4: Clearest available frame of the victim in white 'FREEDOM' shirt showing posture and positioning immediately following the incident. The edge of the RØDE Wireless PRO microphone circuit board is partially visible.
